FINAL REPORT NUMBER 201U-MGA-04-06

SAFETY COMPLIANCE TESTING FOR FMVSS 201U
Occupant Protection In Interior Impact
Upper Interior Head Impact Protection

LAND ROVER IN THE UK
2004 LAND ROVER FREELANDER SE MPV
NHTSA No. C40602

MGA RESEARCH CORPORATION
446 Executive Drive
Troy, Michigan 48083

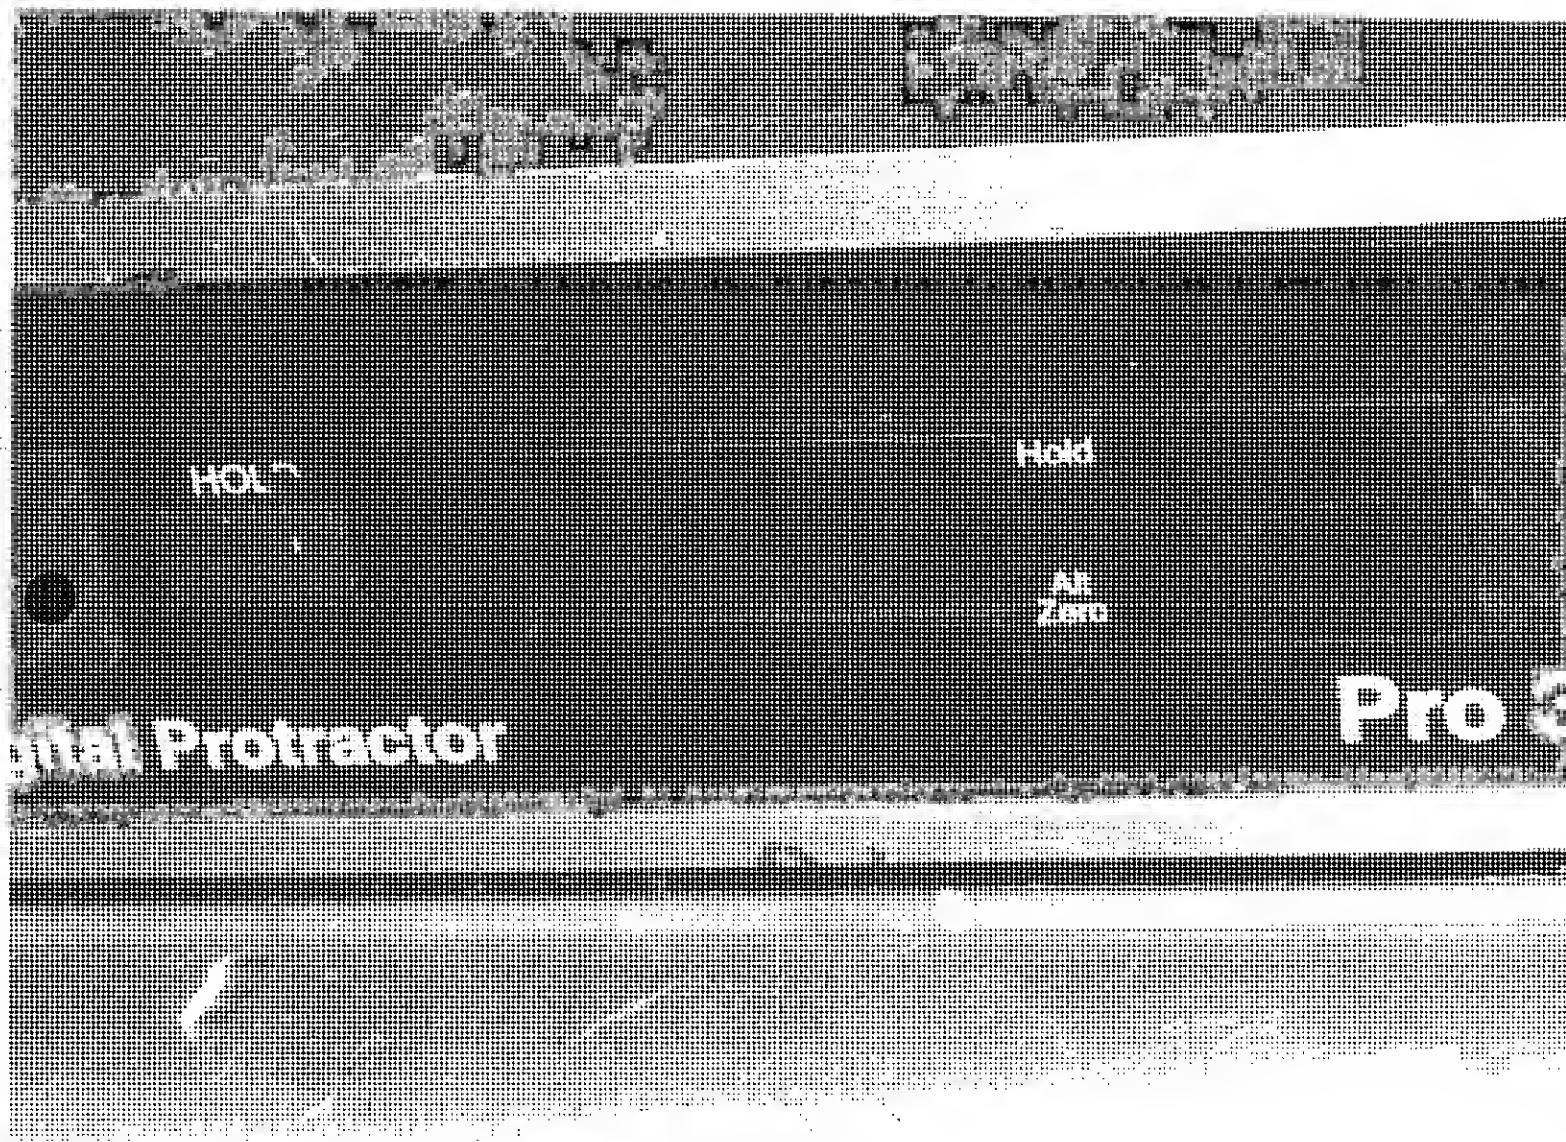
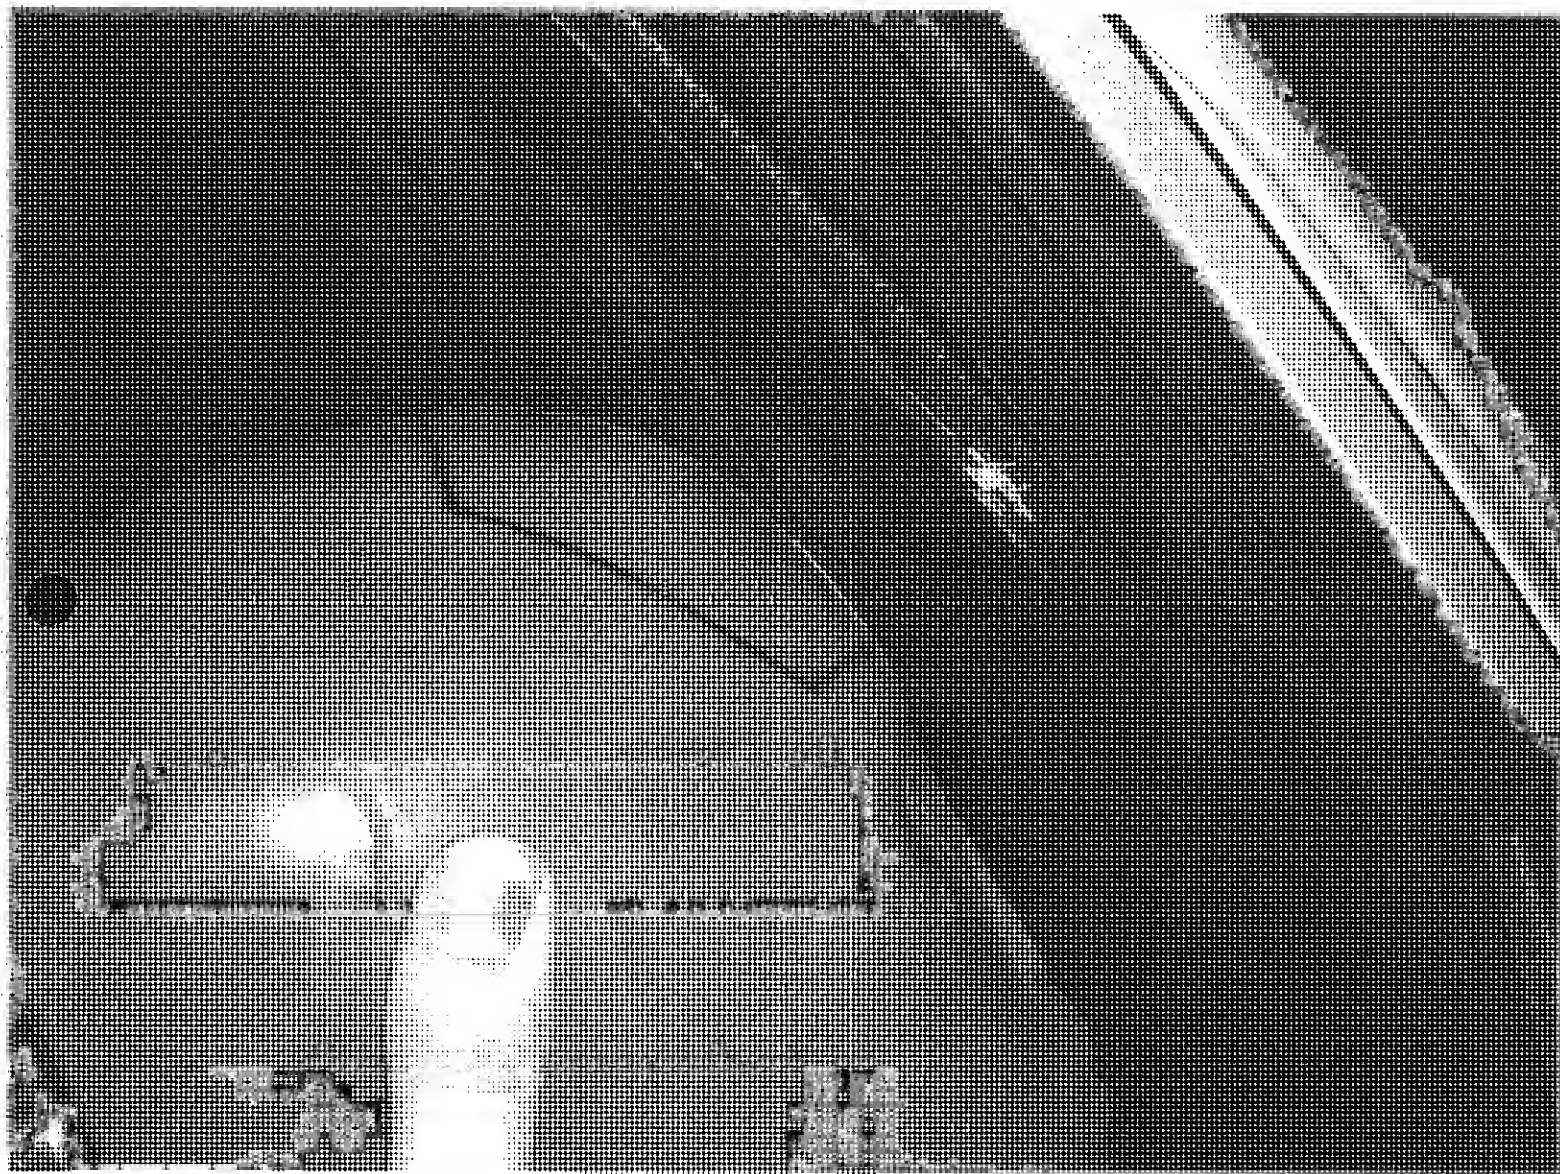
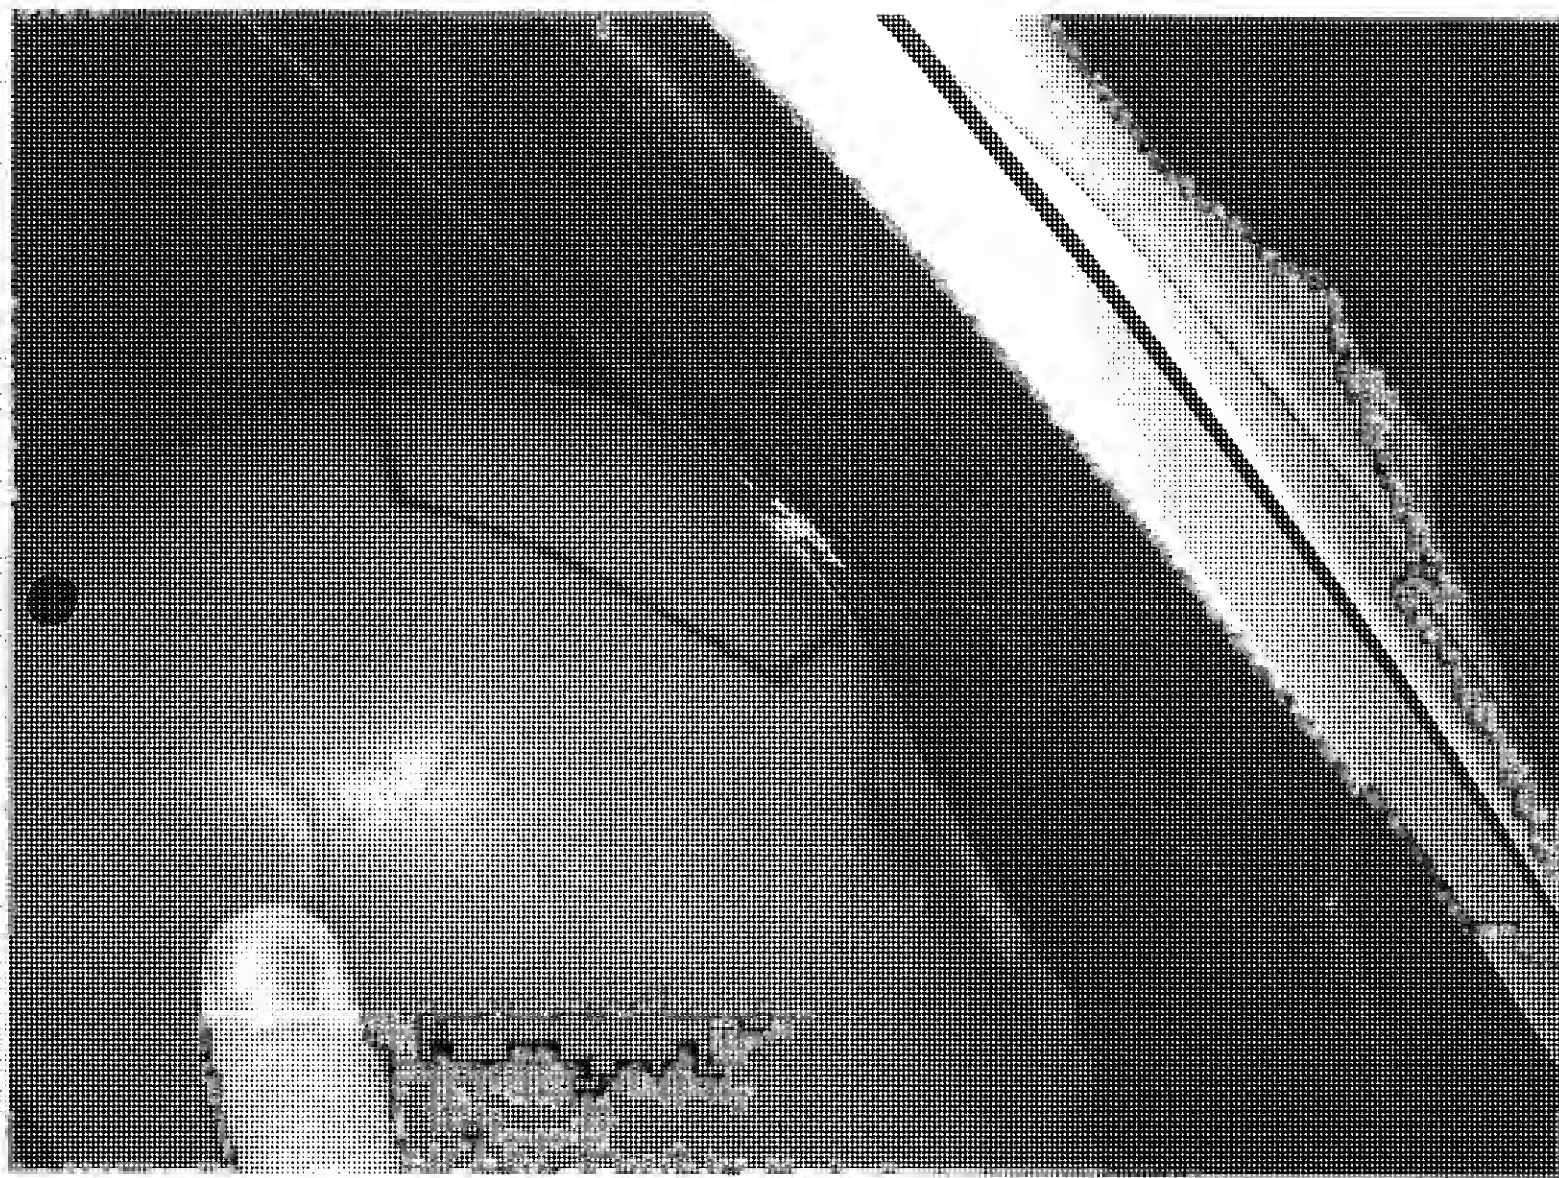
POST TEST

AP3 Right: No visible damage. Apparent test failure.

4/20/04 Impact Testing
G0417-001.7
2004 LAND ROVER FREELANDER
FMVSS 201U - UPPER INTERIOR
C40602 TEST#1 RIGHT AP3
HV IMPACT ANGLE = 152 / 31
FM4091 PRE-TEST

NO VISIBLE DAMAGE

APPROXIMATE TEST FAILURE

APPARENT TEST FAILURE DESCRIPTION: A-PILLAR TARGET #3 (AP3), LOCATED ON THE LOWER PORTION OF THE A-PILLAR. THE HORIZONTAL AND VERTICAL ANGLES WERE 152 AND 31 DEGREES RESPECTIVELY. THE CALCULATED HEAD IMPACT CRITERIA(d) WAS 1062, AT AN IMPACT VELOCITY OF 23.9 KPH.

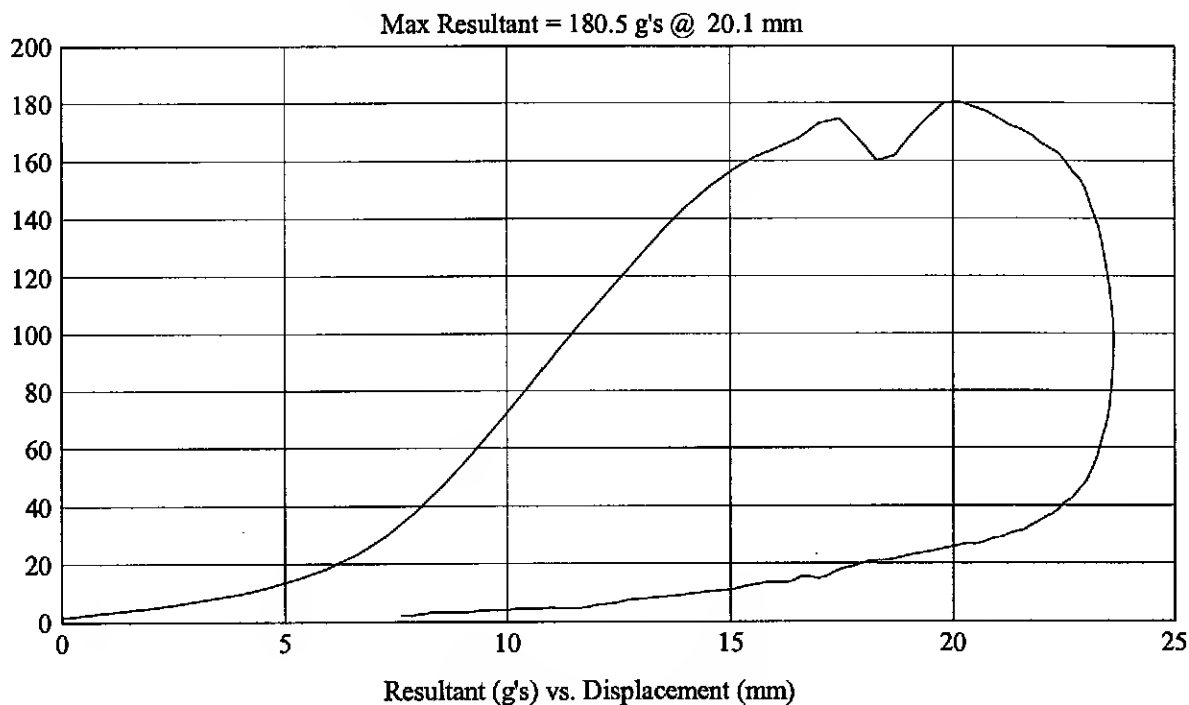
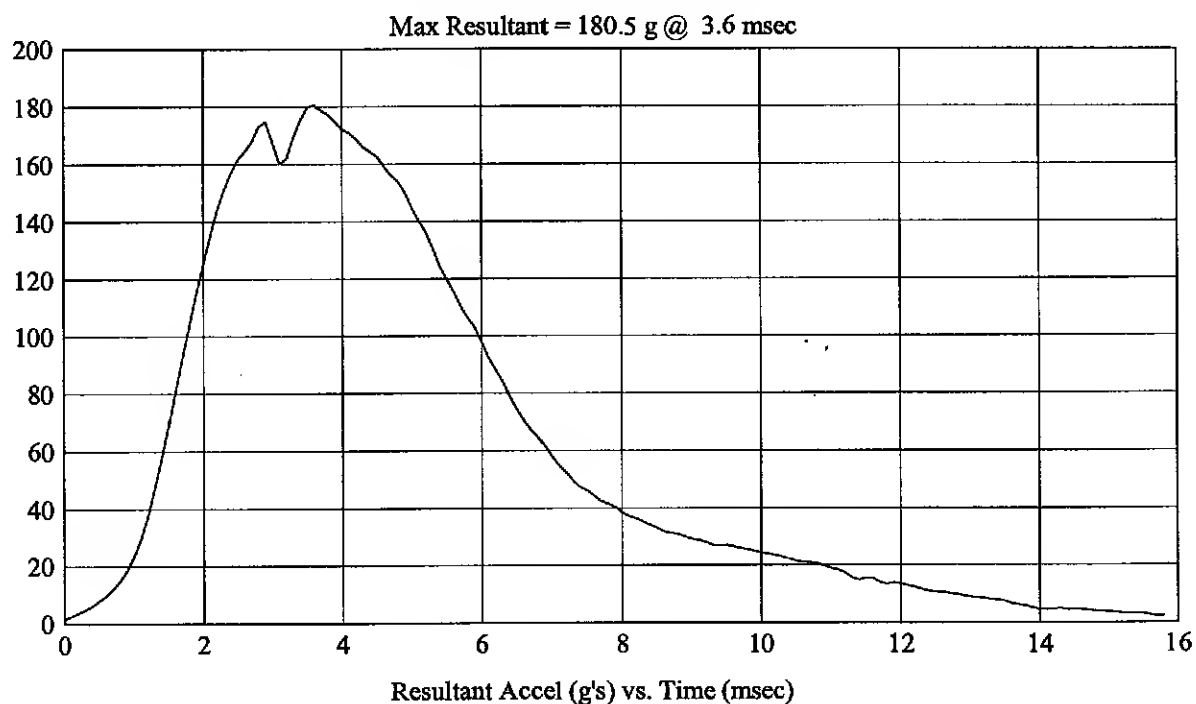
FMH
G04I7-001.7Customer: LAND ROVER
Test # 1
FM4091
Additional Desc: N/A

Model Year: 2004
Target: AP3
Vehicle Side: Right
Horz/Vert Angle: 152/31

HIC(d) = 1062, HIC = 1187, Delta T = 4.5 msec

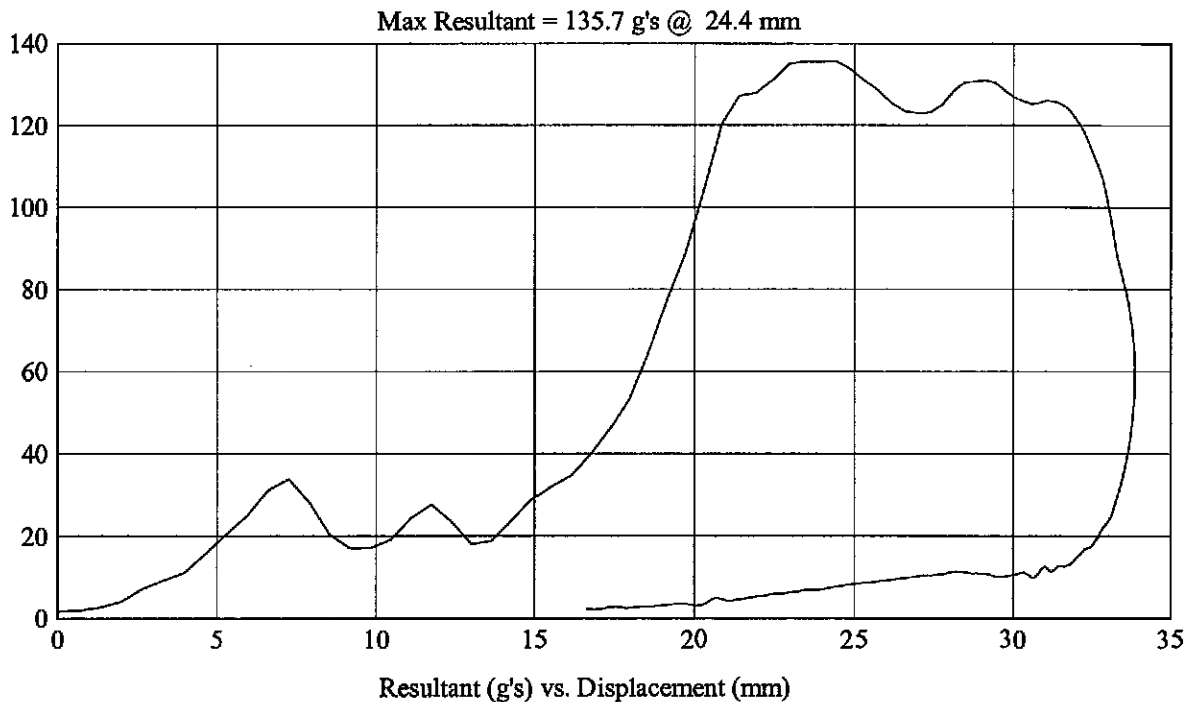
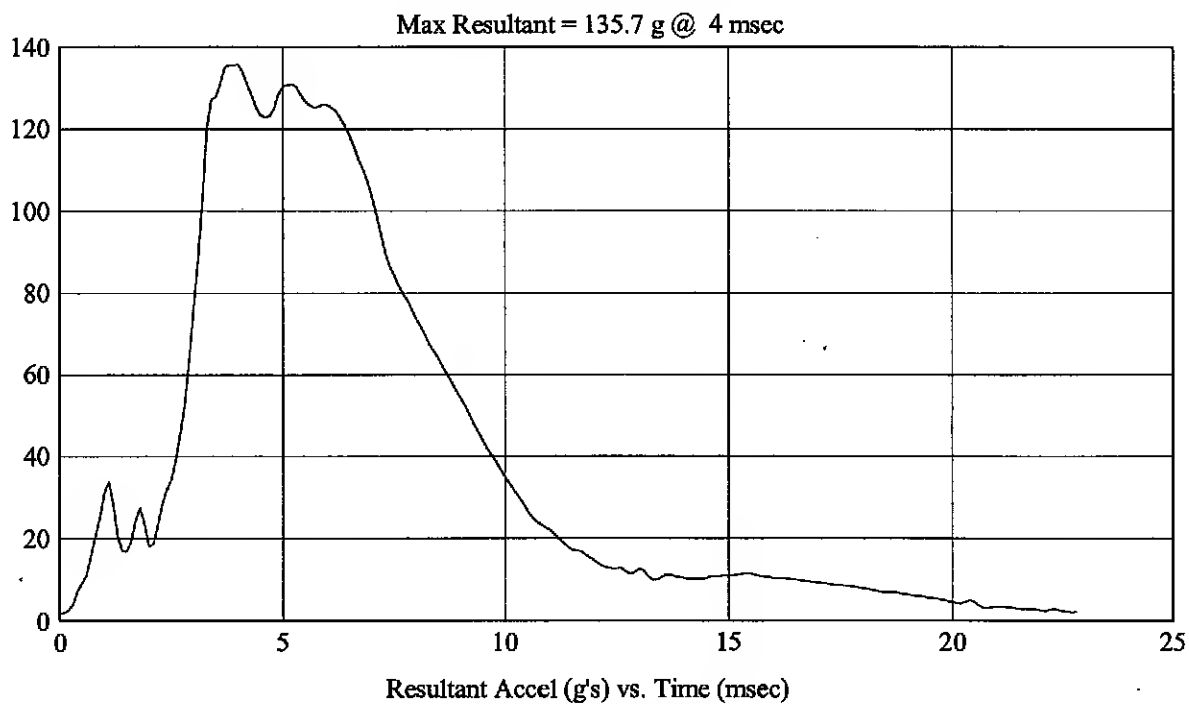
FMH
G04I7-001.7Customer: LAND ROVER
Test # 4
FM4094
Additional Desc: N/A

BP2 Right: The seat belt anchorage cover was cracked during impact.

SEAT BELT ANCHORAGE COVER WAS CRACKED DURING IMPACT

Model Year: 2004
Target: BP2
Vehicle Side: Right
Horz/Vert Angle: 90/3

HIC(d) = 714, HIC = 725, Delta T = 5.4 msec

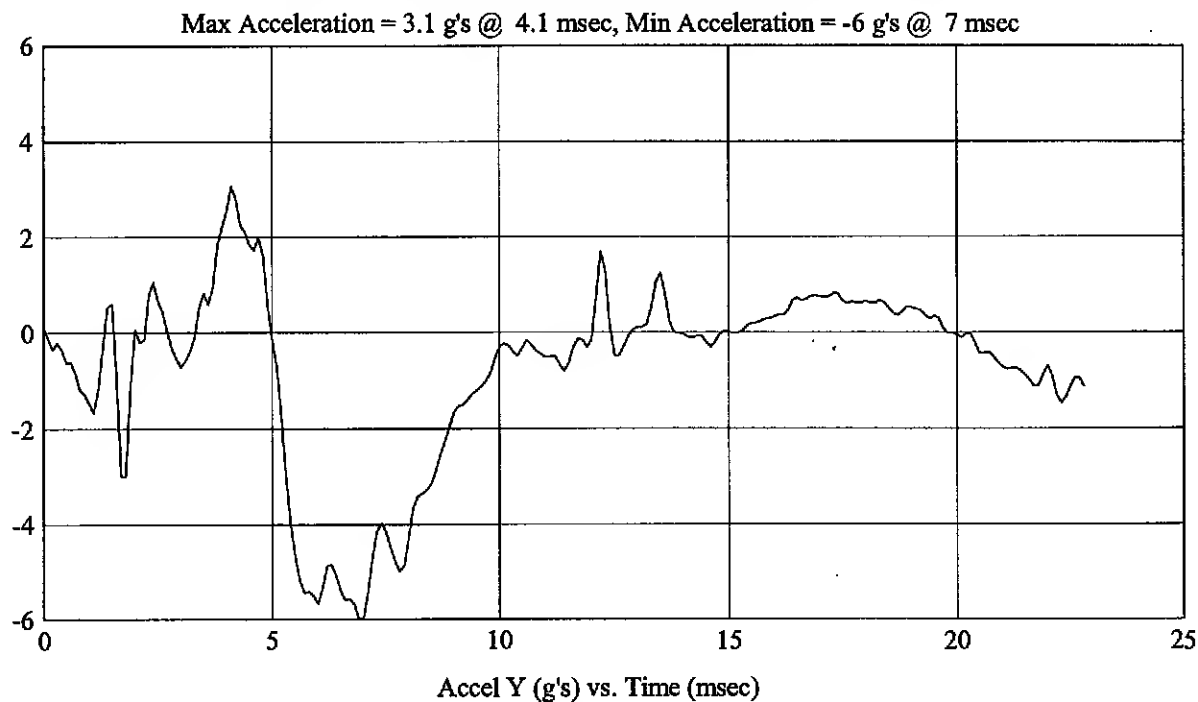
FMH
G04I7-001.7Customer: LAND ROVER
Test # 4
FM4094
Additional Desc: N/A

Model Year: 2004
Target: BP2
Vehicle Side: Right
Horz/Vert Angle: 90/3

HIC(d) = 714, HIC = 725, Delta T = 5.4 msec

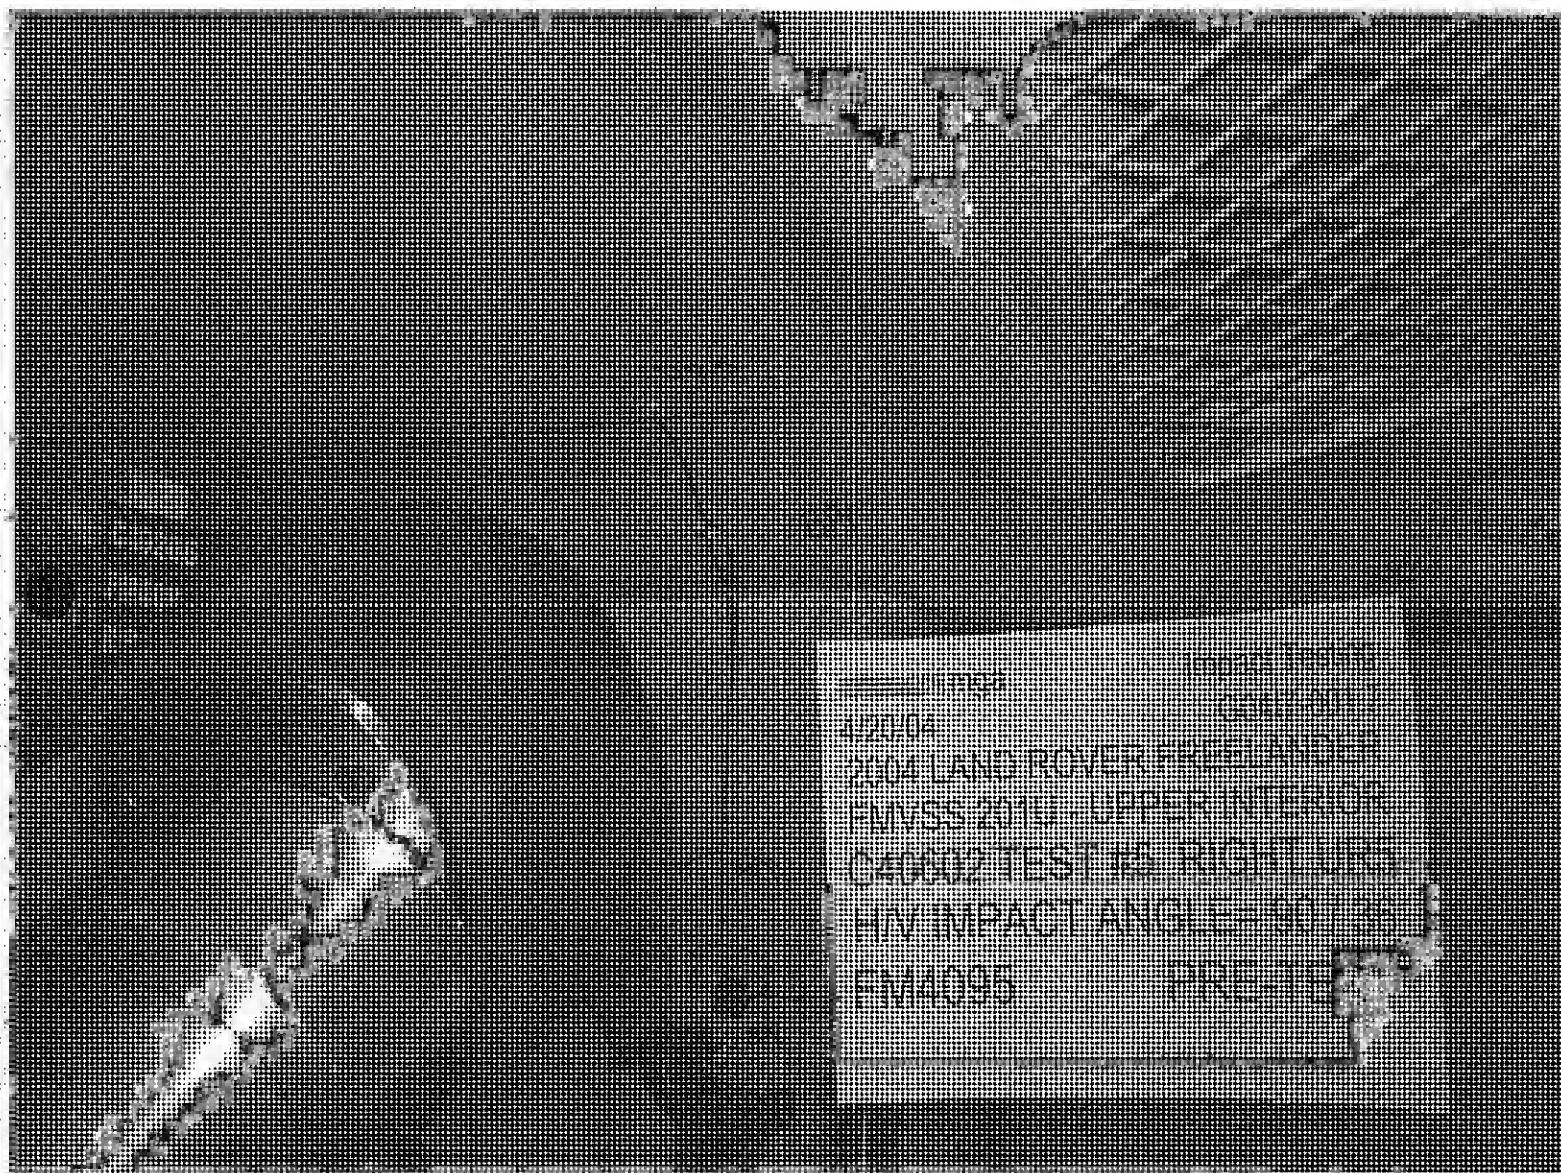
C40602 TEST #5 RIGHT UR5

B-PILLAR TRIM WAS COMPRESSED
